**KOOTENAI DEVELOPMENT IMPOUNDMENT DAM
DECEMBER 2010 ROUTINE OWNERS INSPECTION**

Prepared for: The Remedium Group

Prepared by: Kurt Hafferman, P.E.

Inspection Date: January 07th, 2011
Report Date: January 11th, 2011

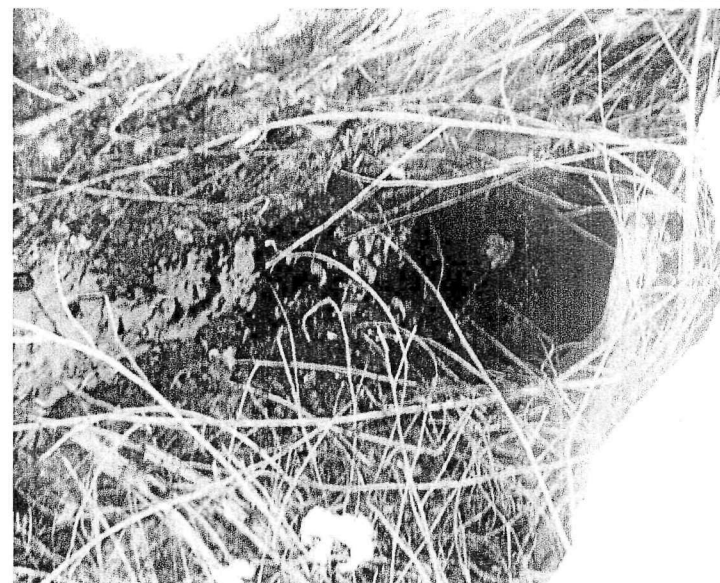
Weir 5 Very Low Flow

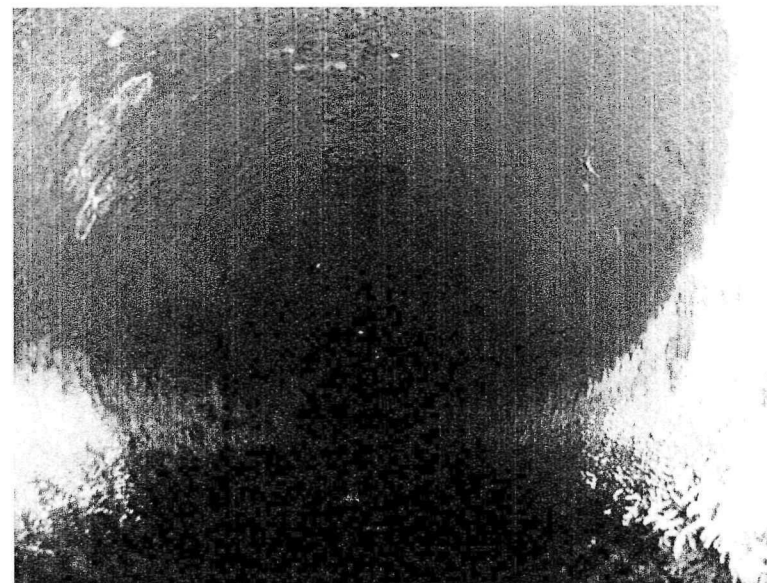
Looking Up Drain 6

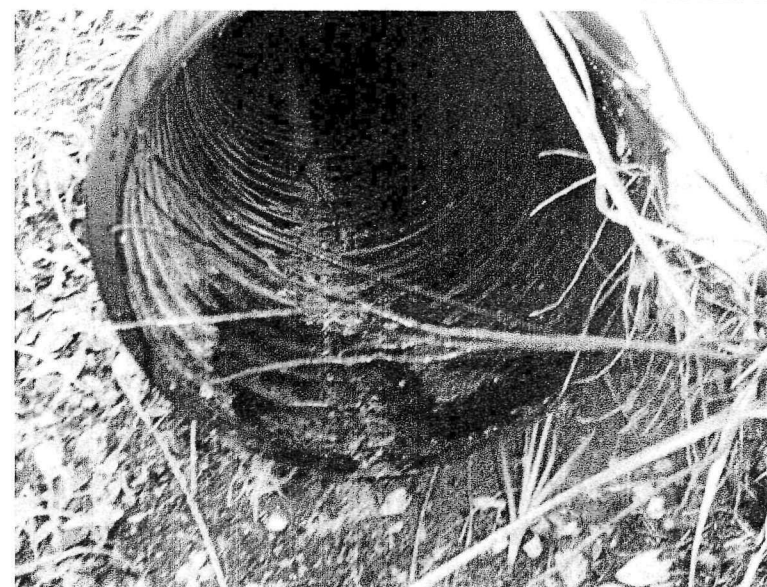
Seepage Below Drain 7

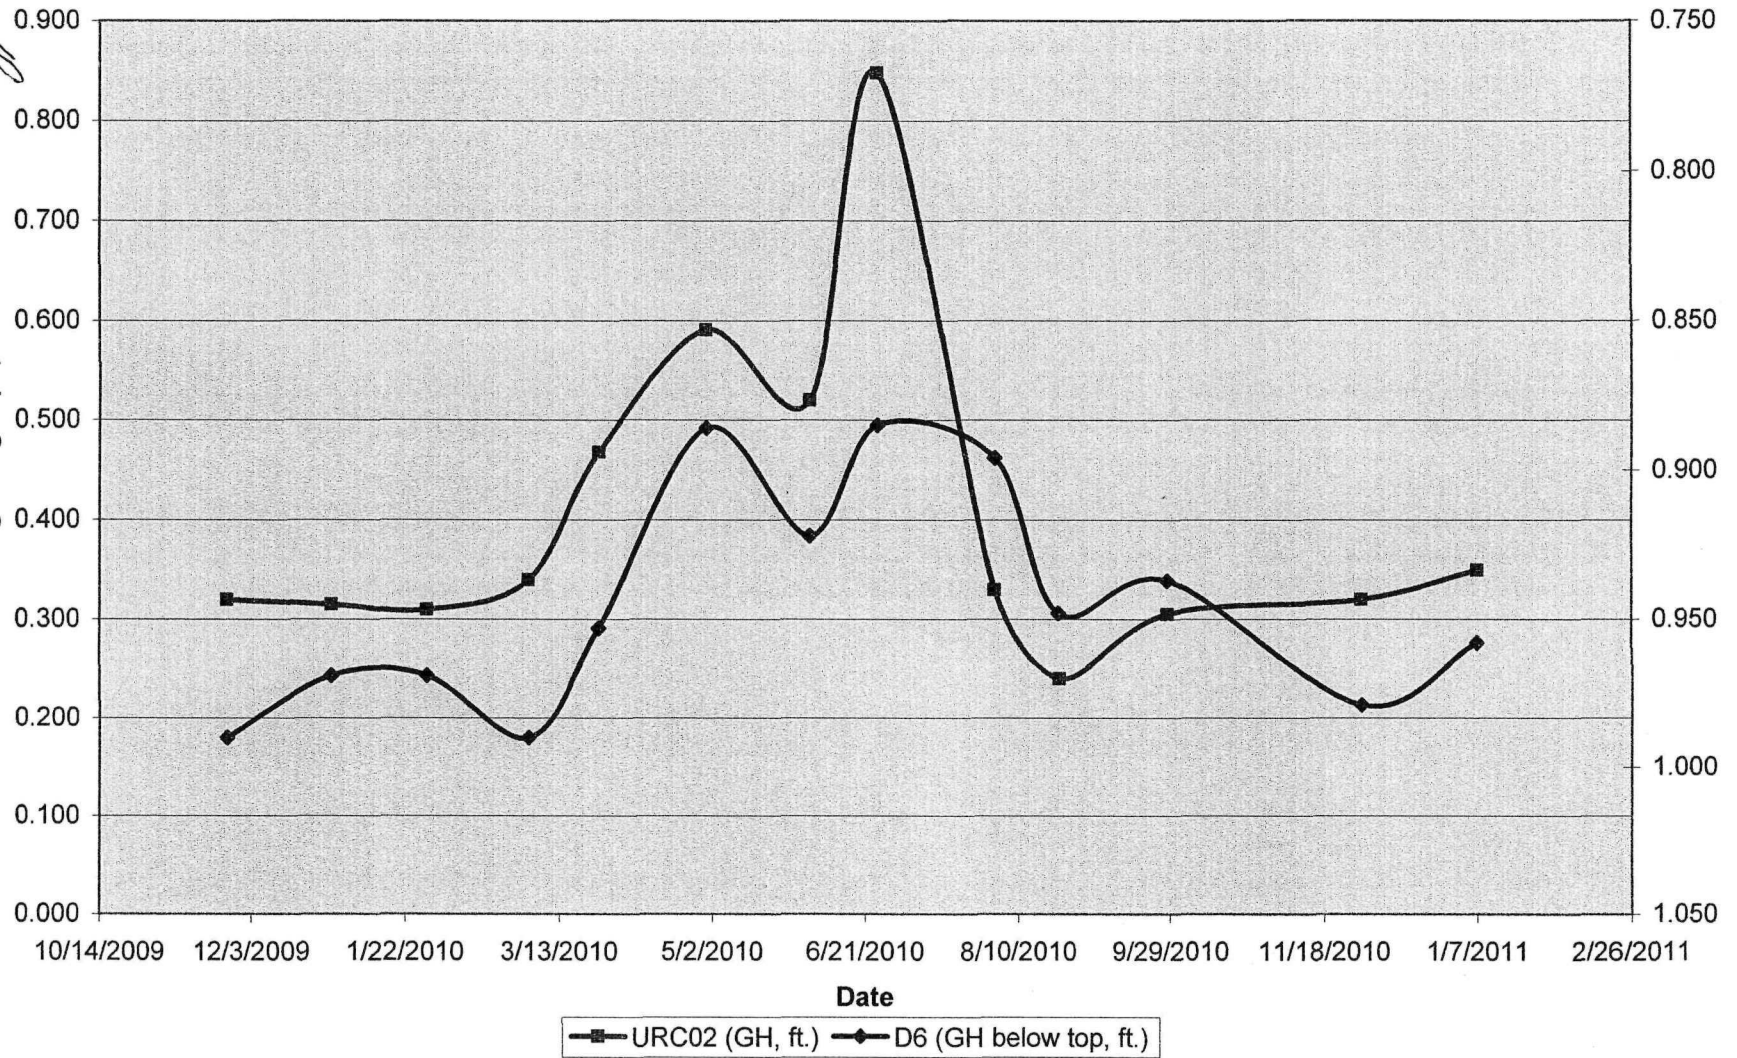
KDID Inflow at Upper Rainy Creek and Drian 6 Comparison
